NATIONAL BUREAU OF STANDARDS REPORT

INVESTIGATION OF THE DIRECTIONAL EFFECTS IN THE STRESS CORROSION OF ALUMINUM ALLOYS

Final Report

April 22, 1968

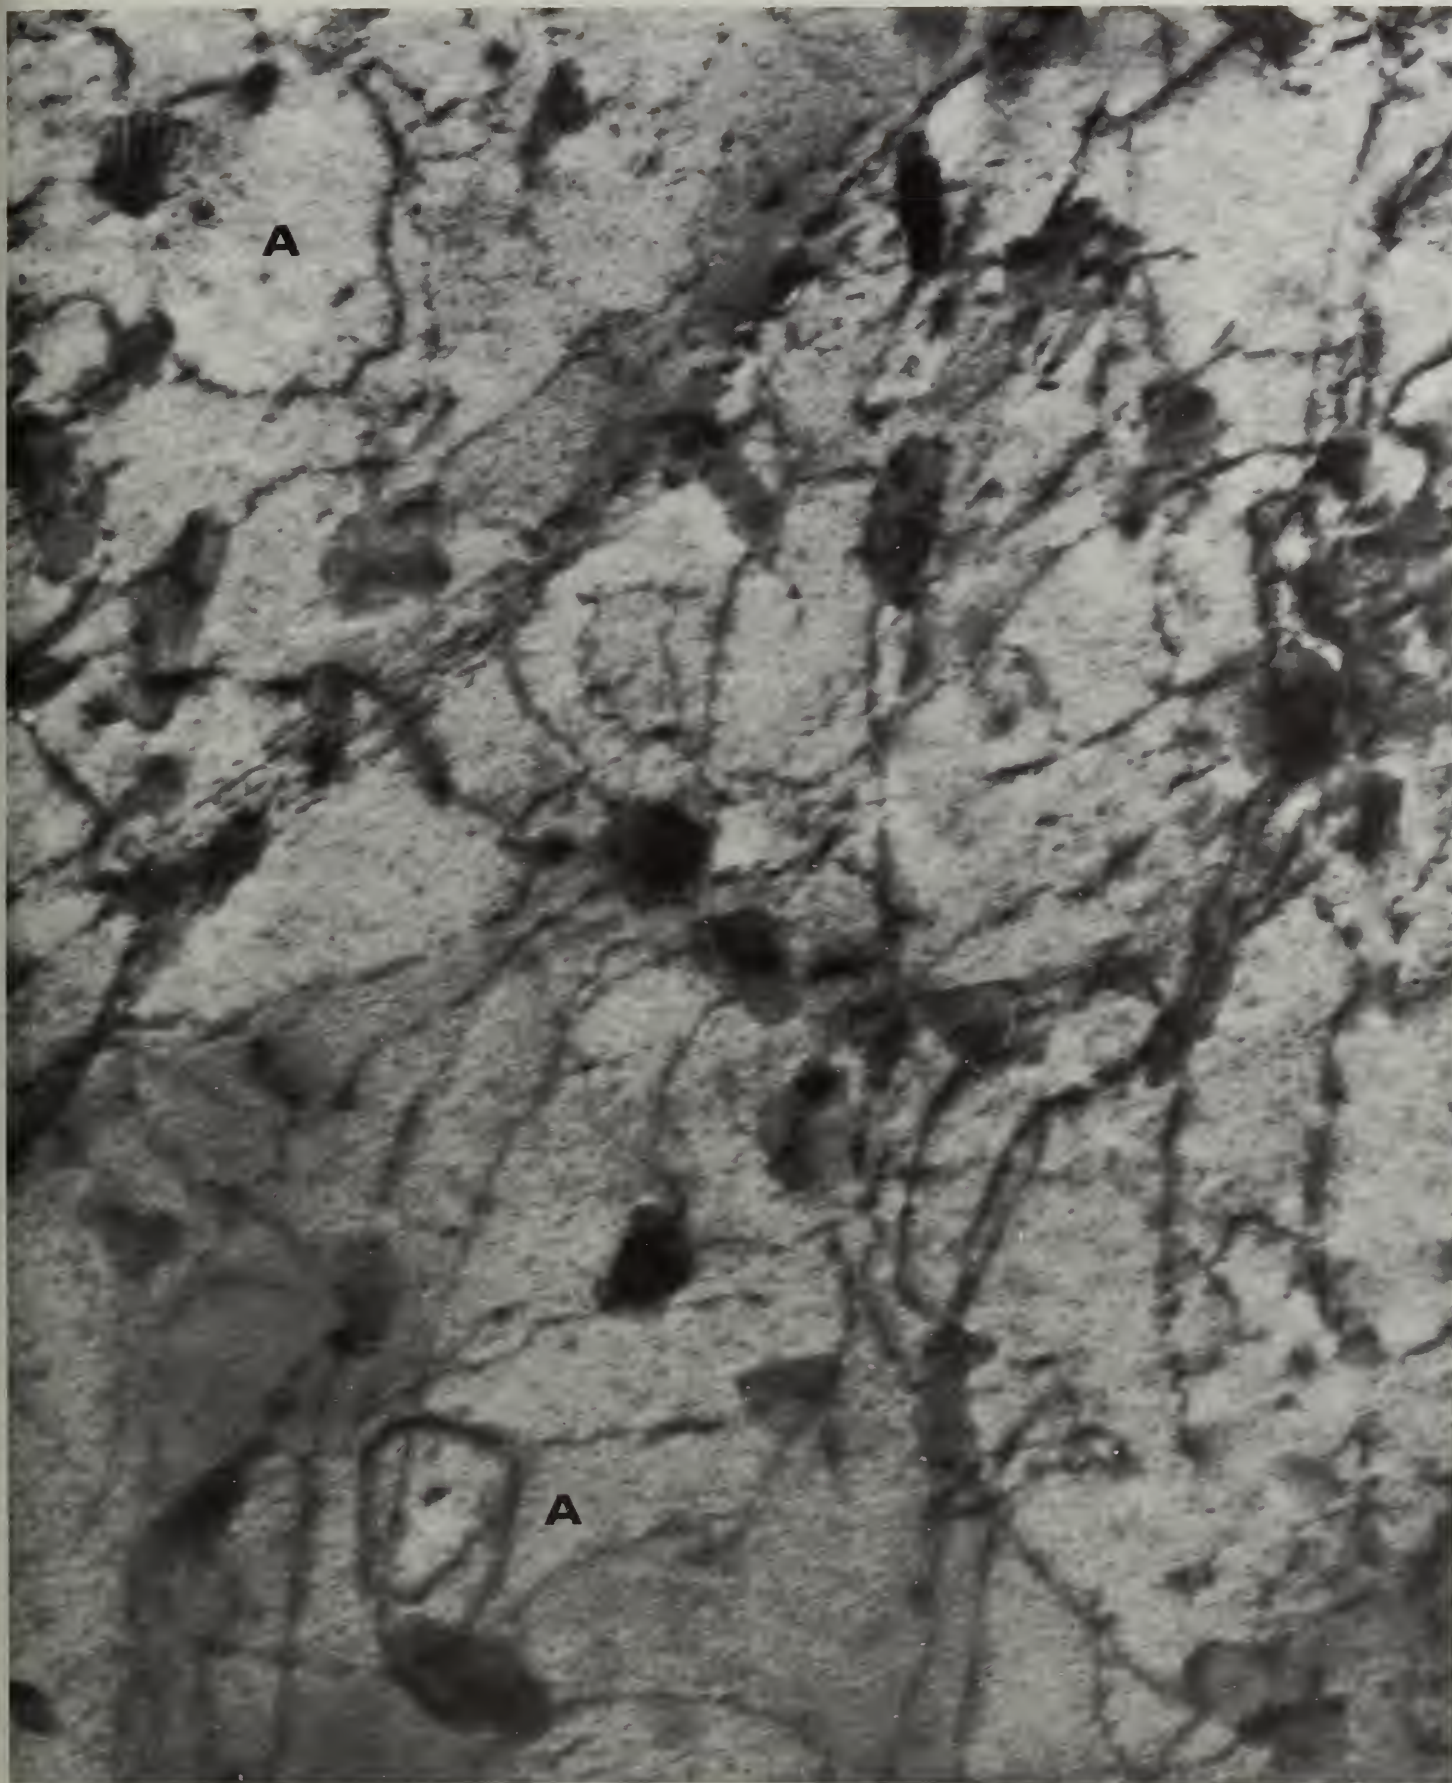
FIGURE 53

An area adjacent to a grain boundary in a long transverse section of a 7075-T651. $M = 155,000$.

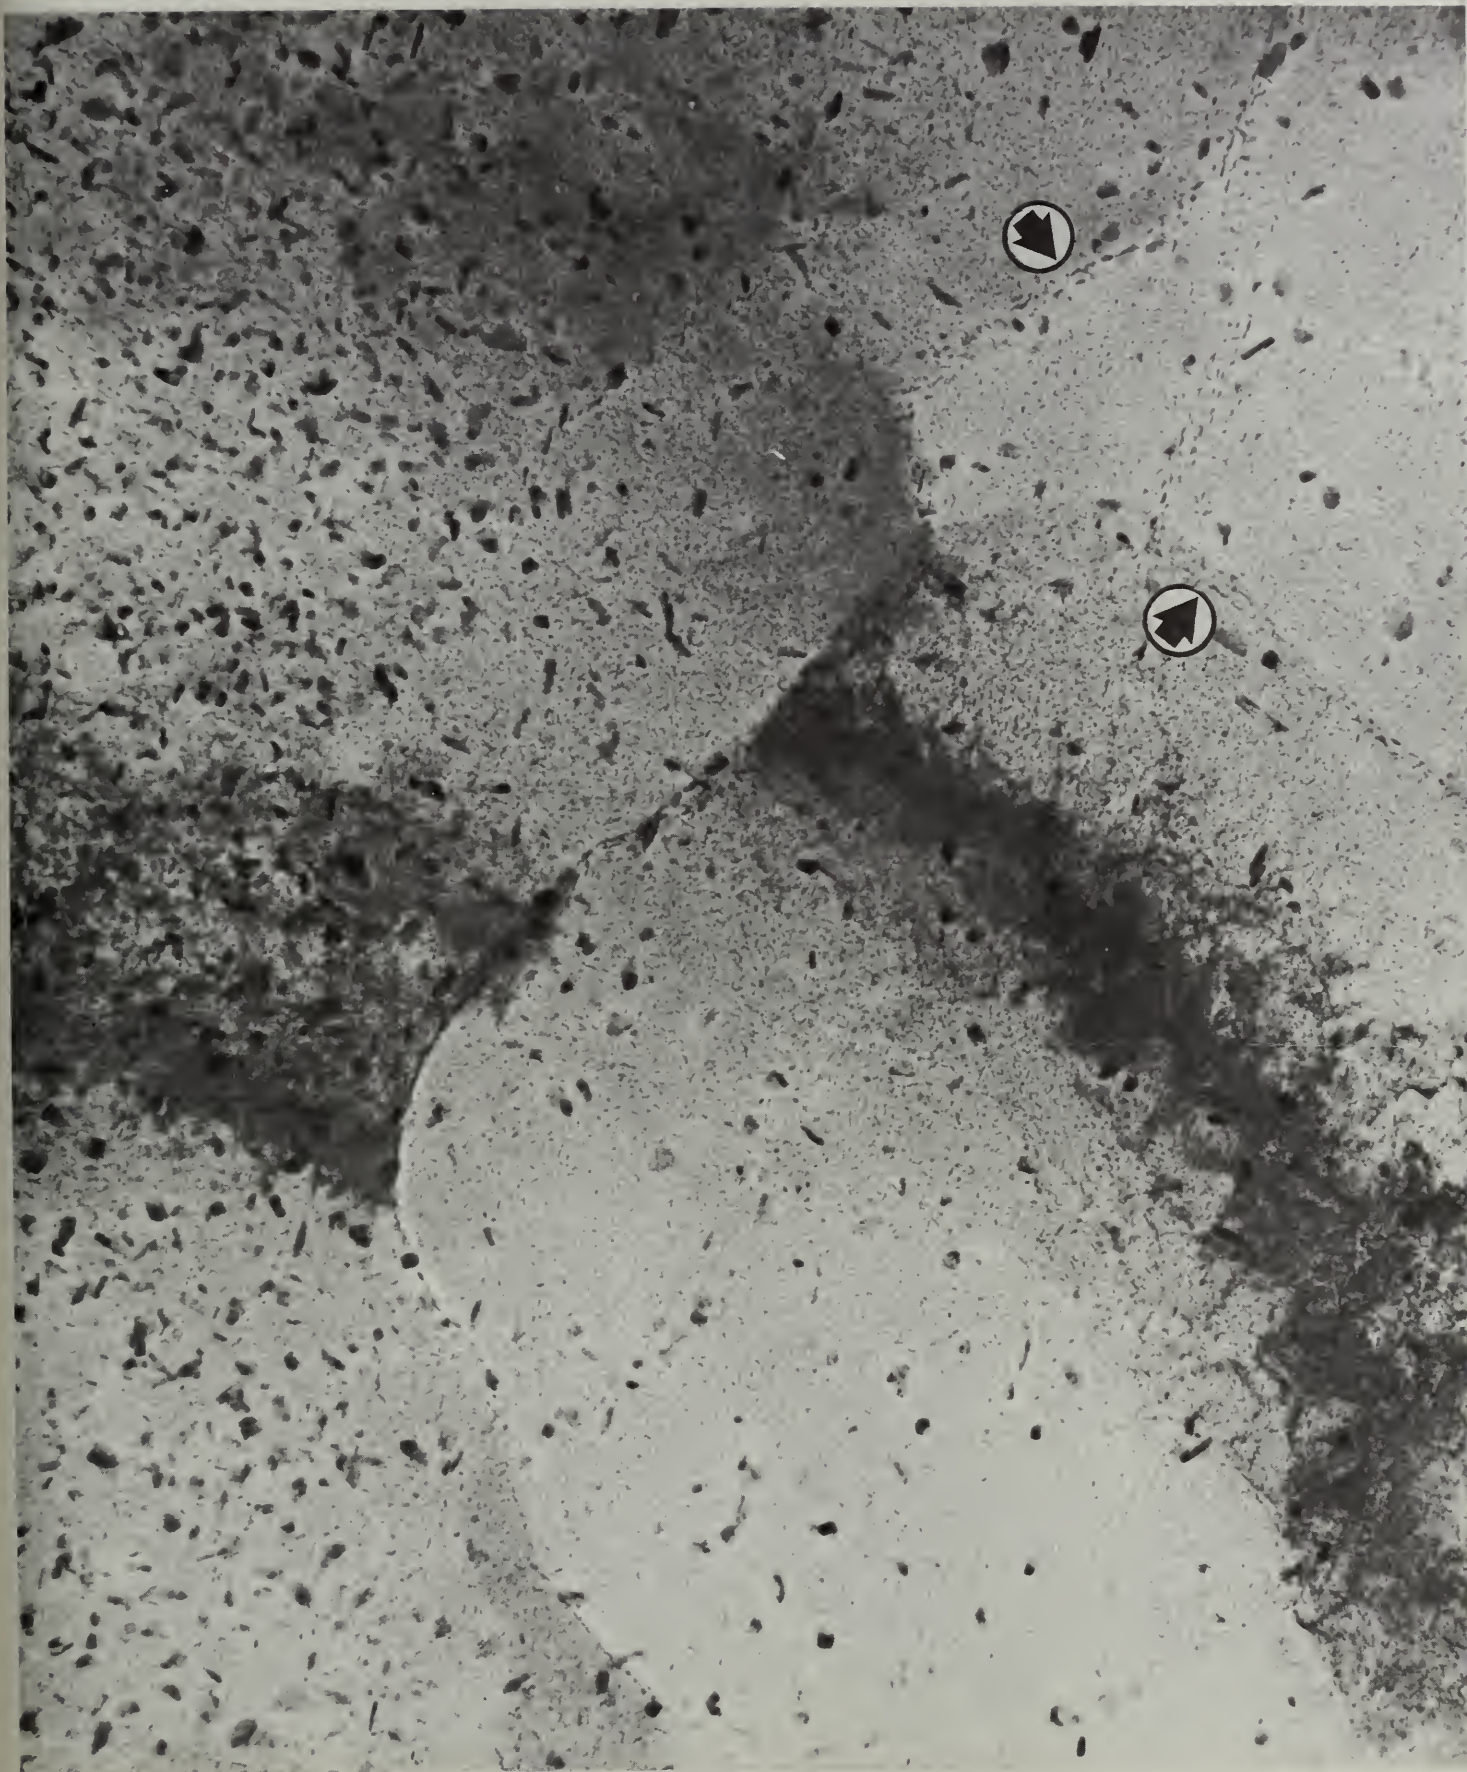
FIGURE 54

Grain and precipitate structures in a short transverse section of a 7075-T73 specimen. $M = 30,000$.

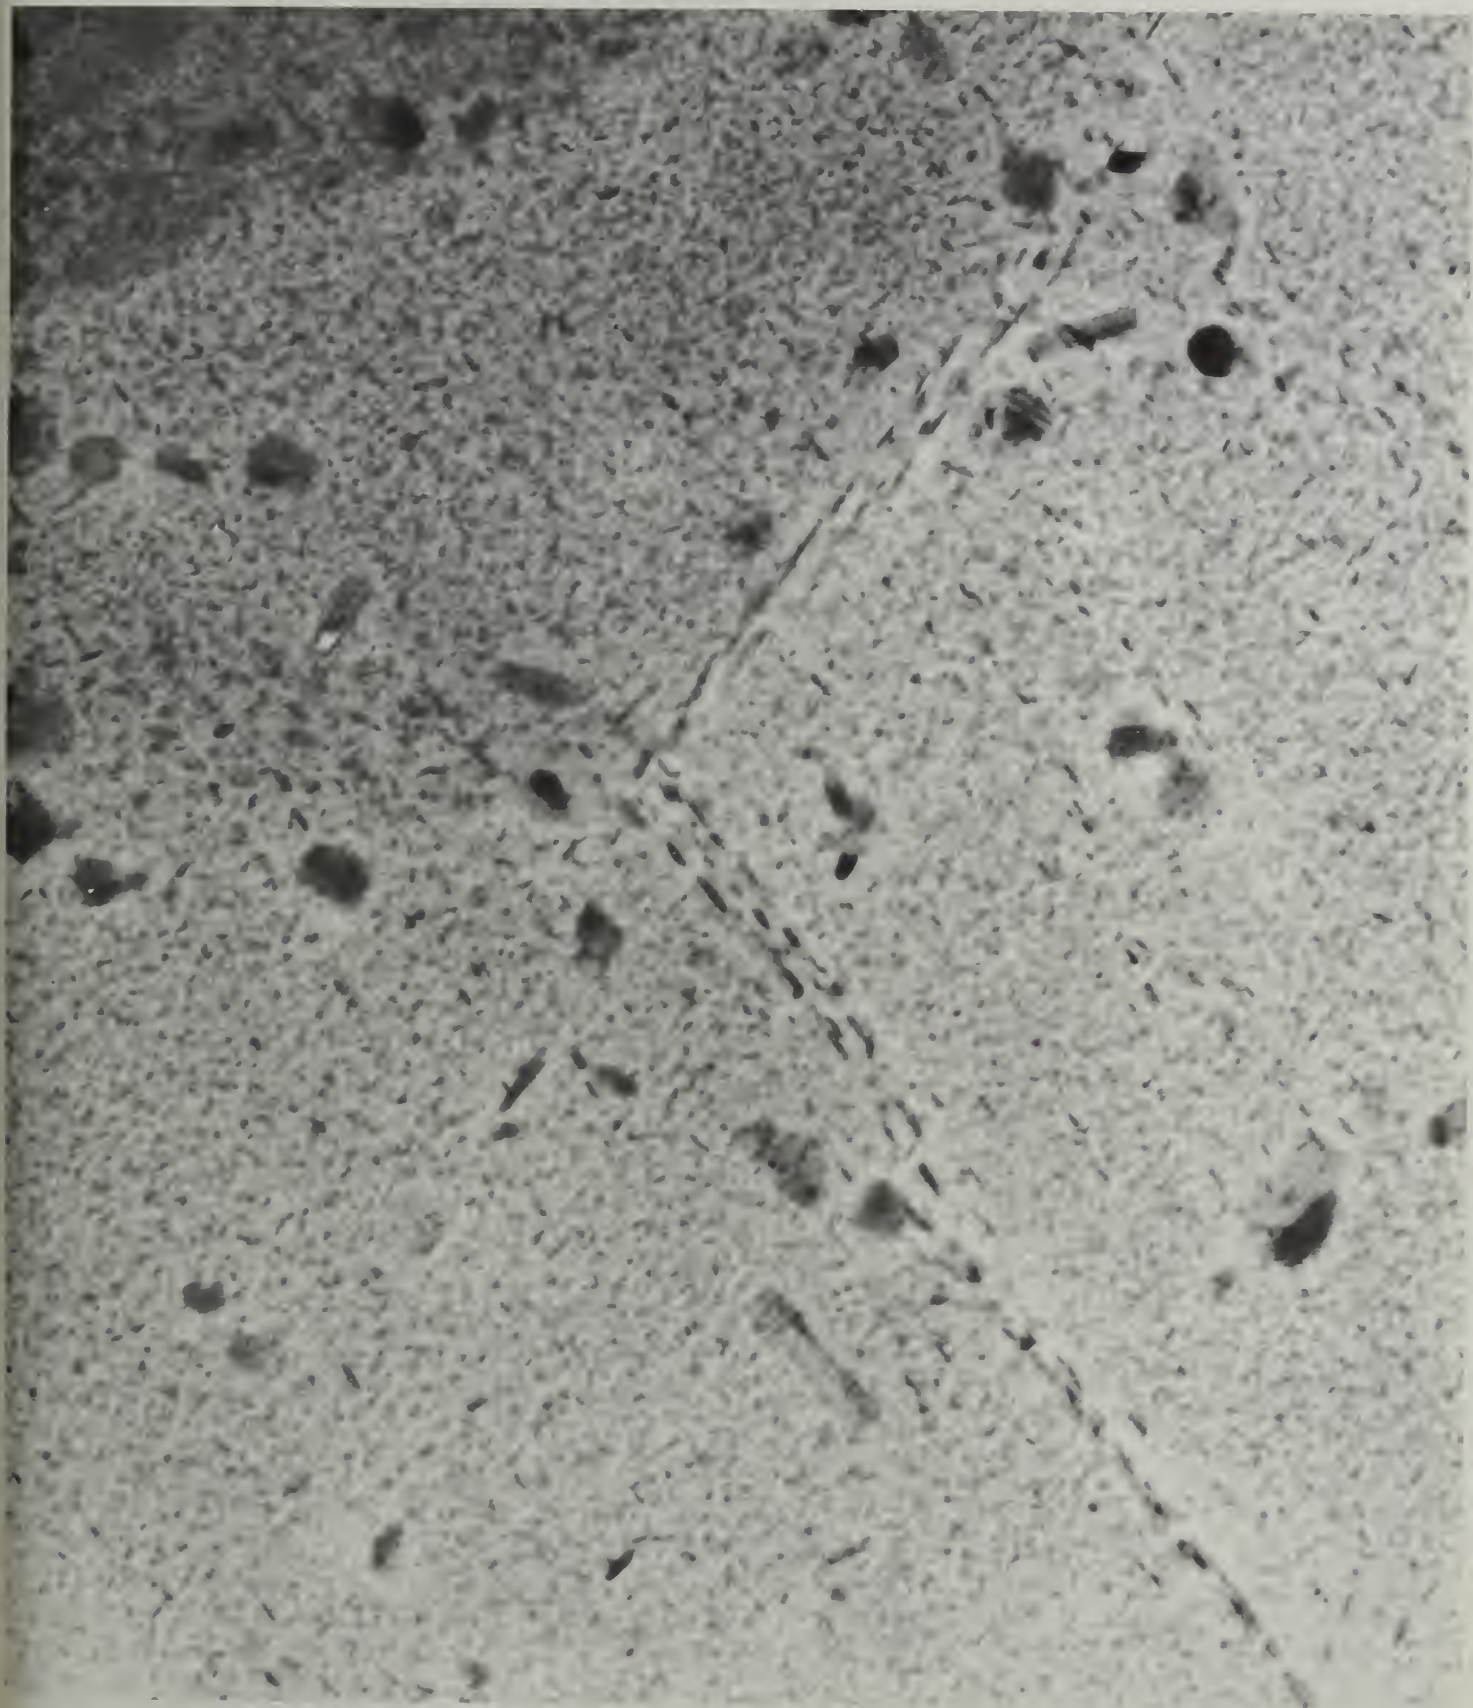
FIGURE 55

A triple grain junction region in the short transverse T73 specimen illustrating boundary precipitation and general precipitate growth. $M = 91,600$.

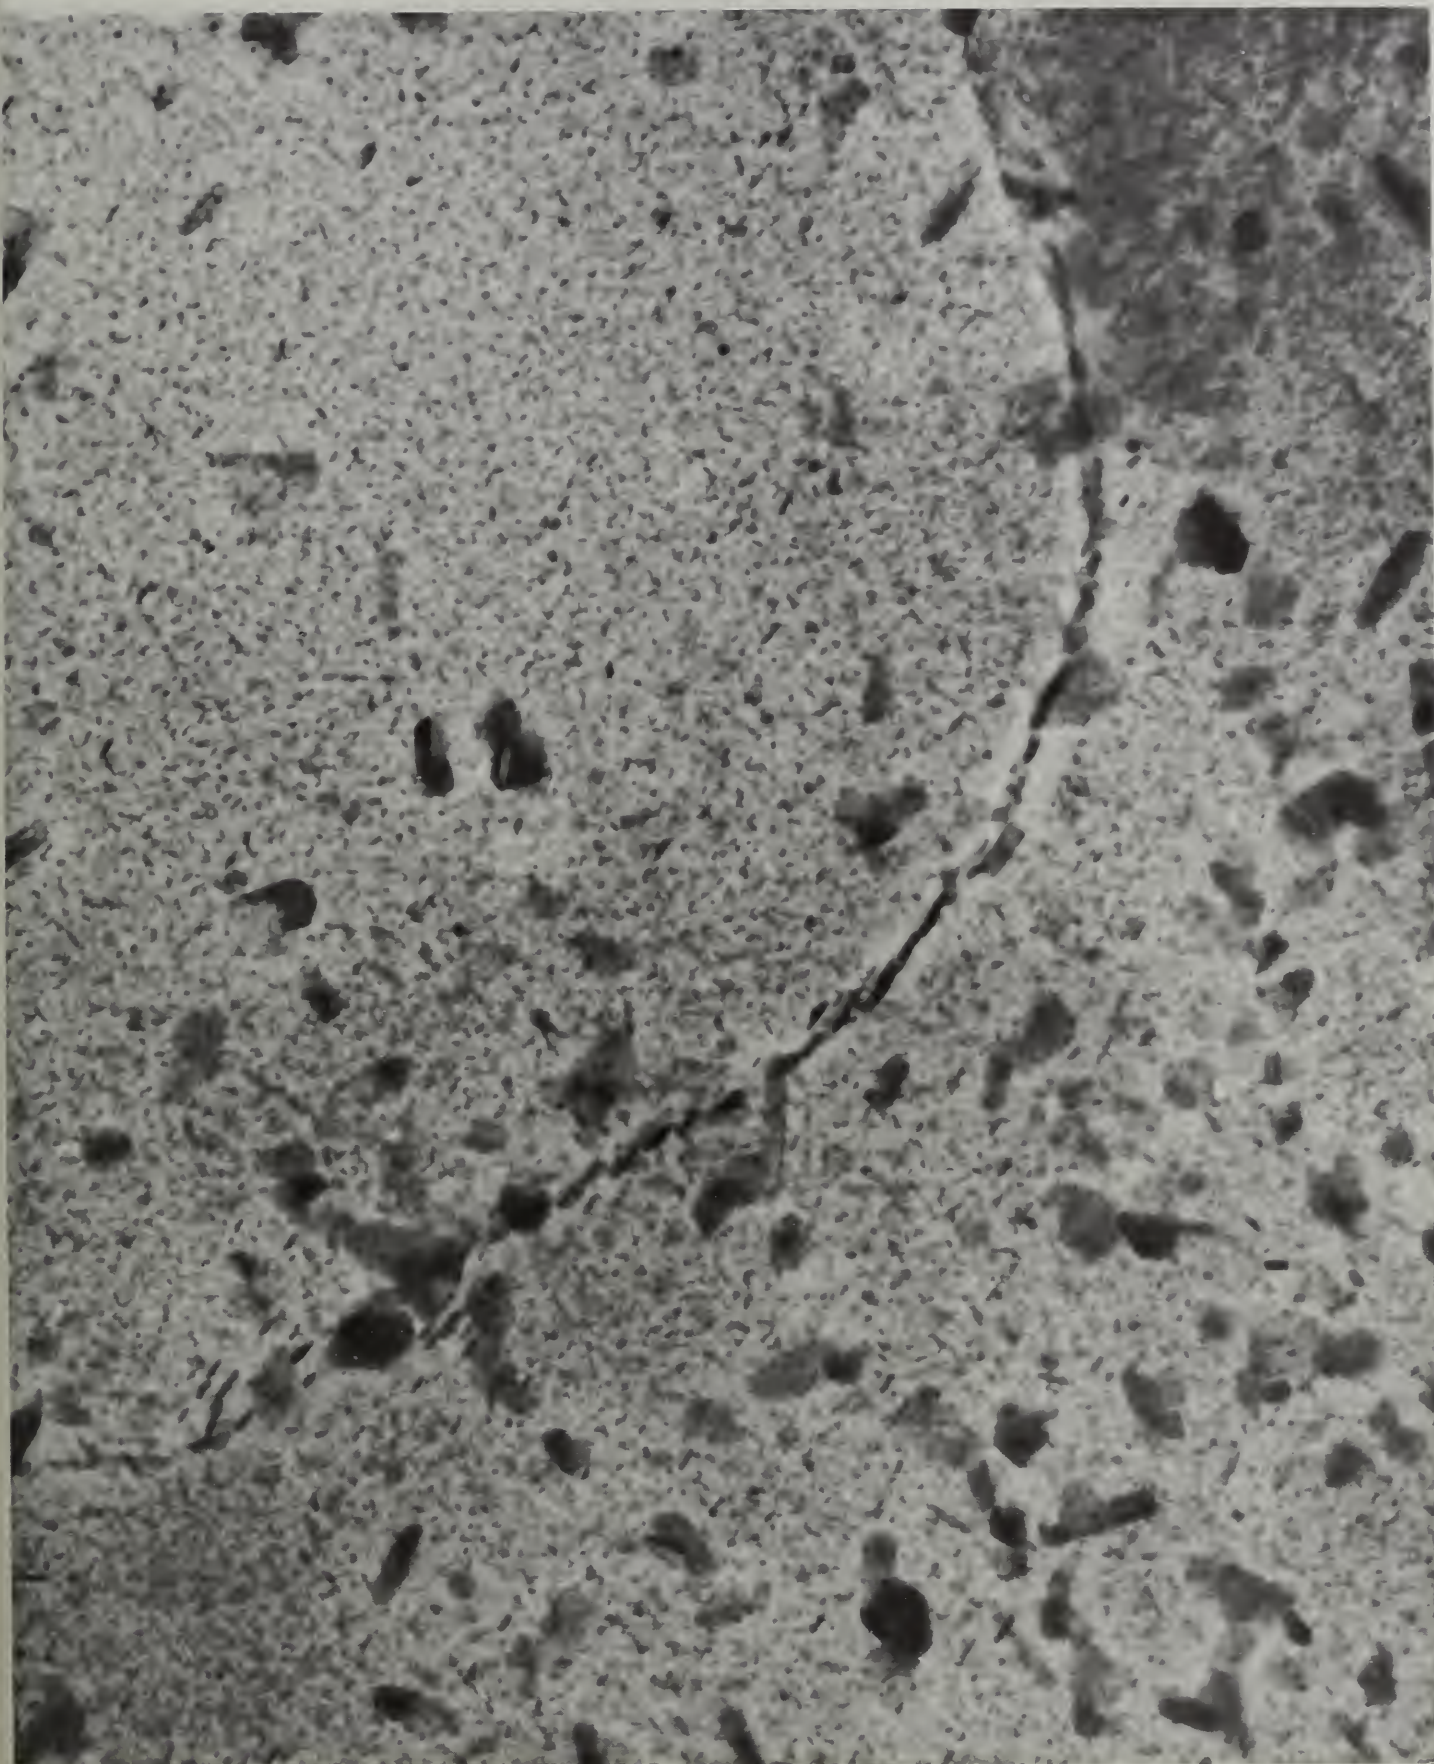
FIGURE 56

Another boundary region in the T73 condition specimen. $M = 91,300$.

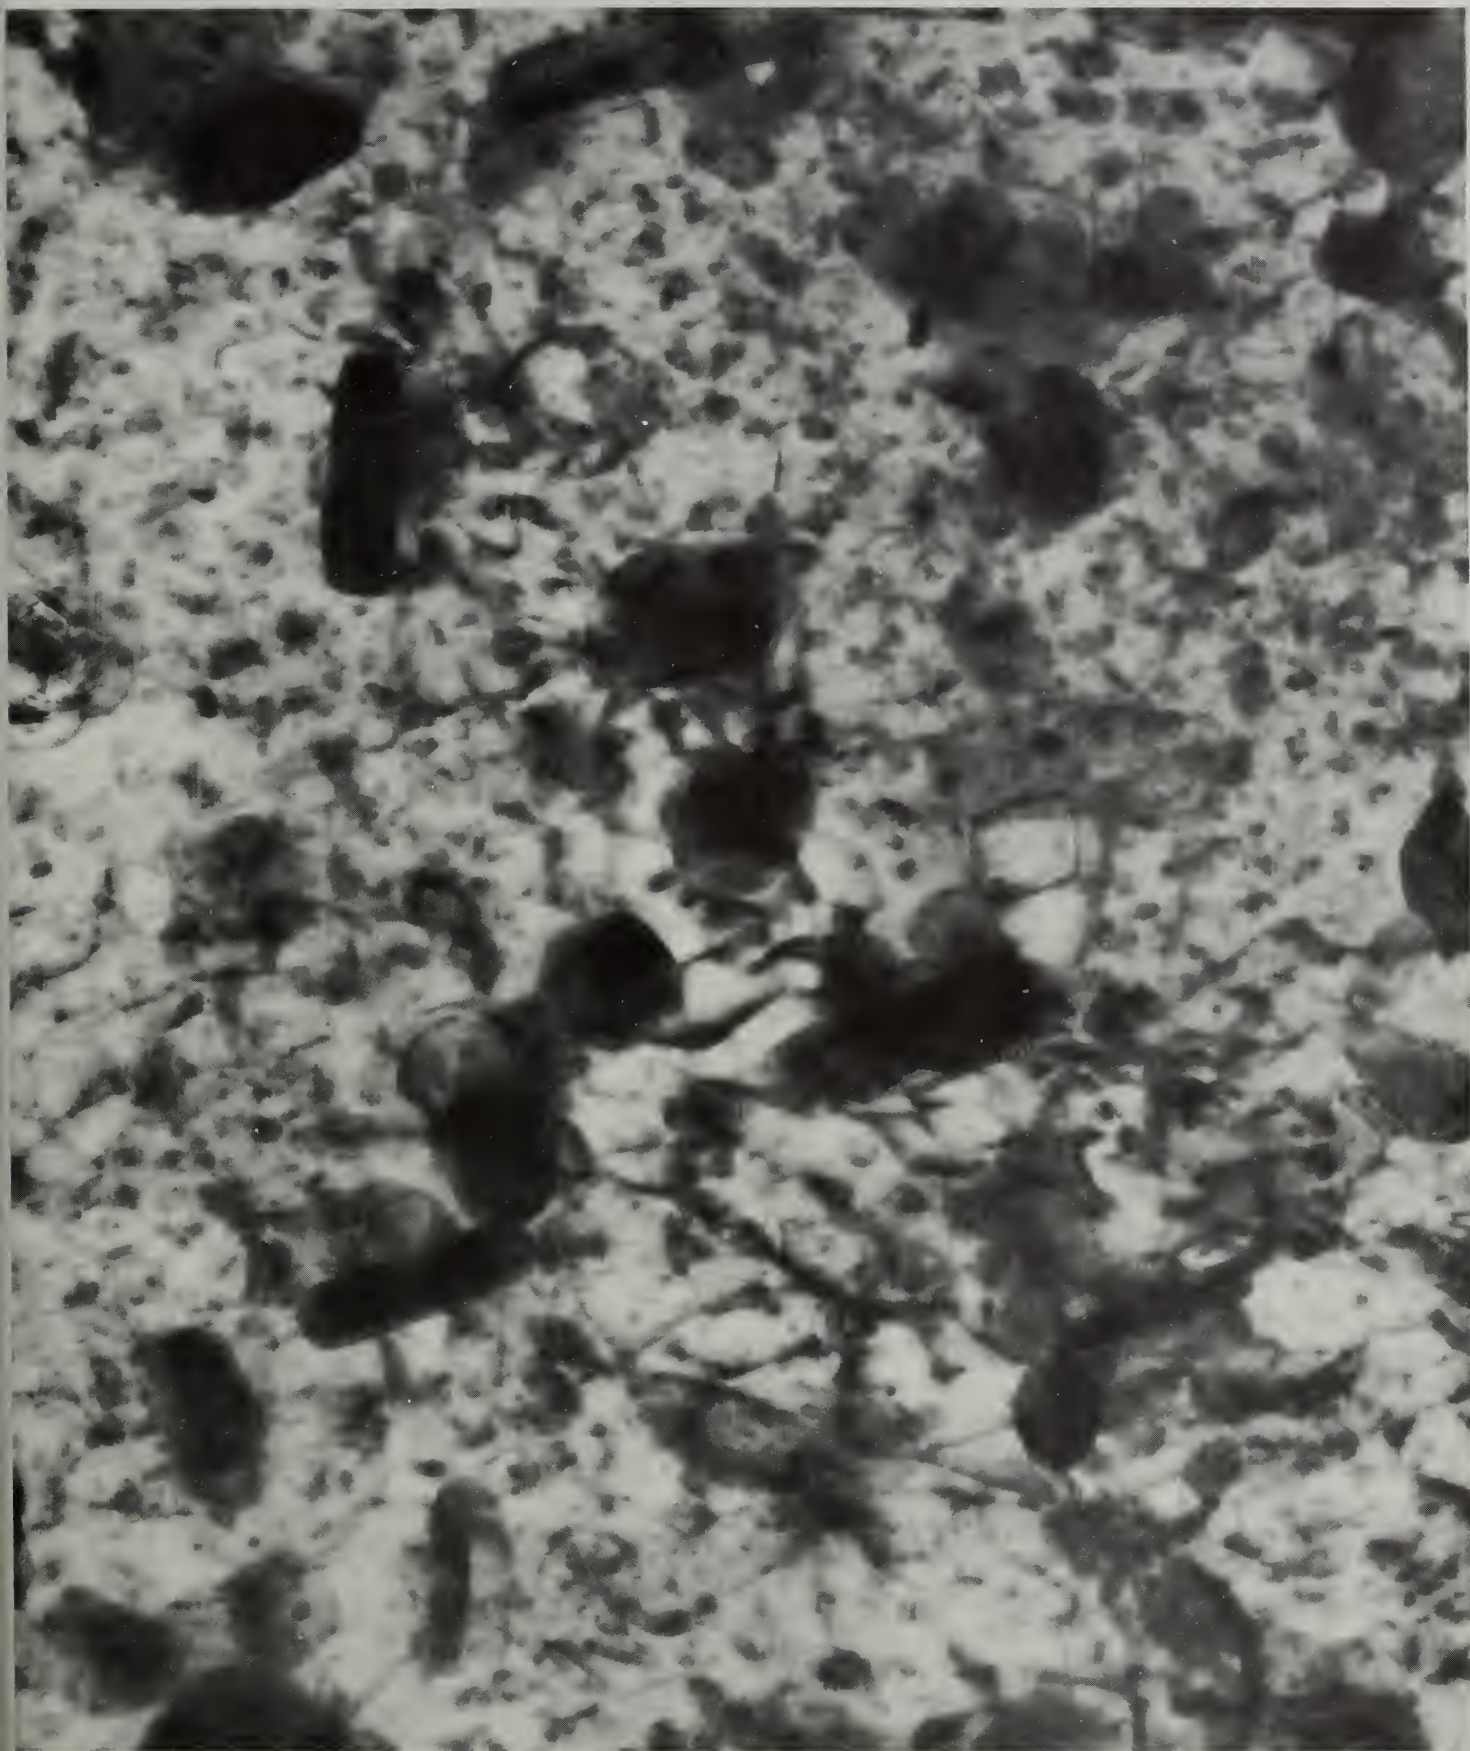
FIGURE 57

Dislocation-precipitate interactions in a short transverse section of the T73 specimen. $M = 268,000$.
